Final Report

Riparian Buffers with ECCD: Ledyard CT

Pfizer Field Project

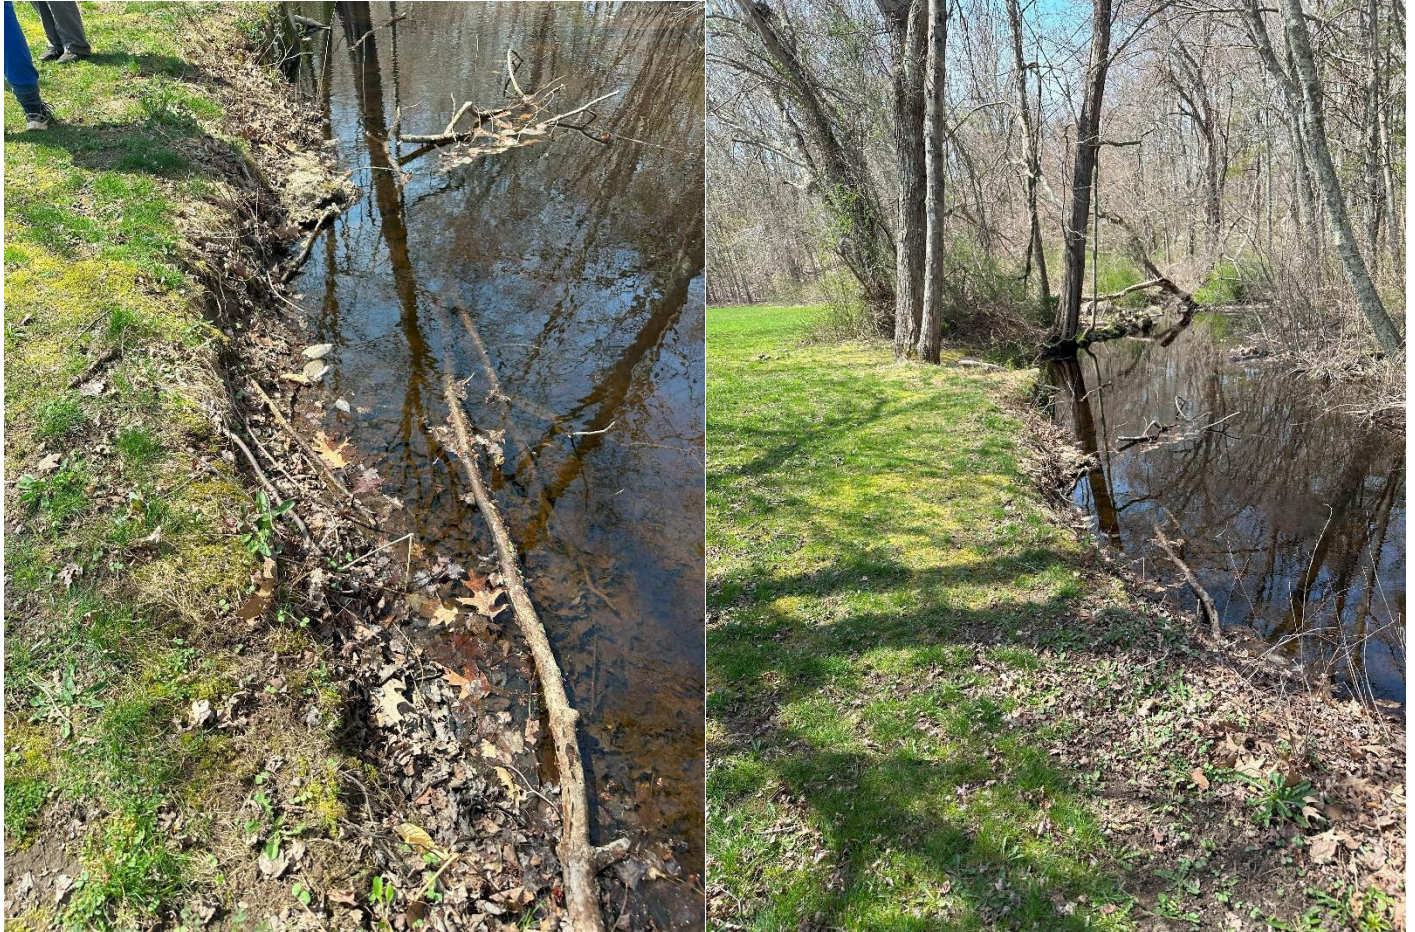
The right image highlights the view of the bank with the lack of plants and no actual buffer present. In the bottom of that image, you can see a small patch of the invasives that take over the majority of the bank. The left image shows some evidence of erosion of the bank, there is a very steep drop off along most of it and there are some exposed roots that you can see poking through where the dirt has been washed away.

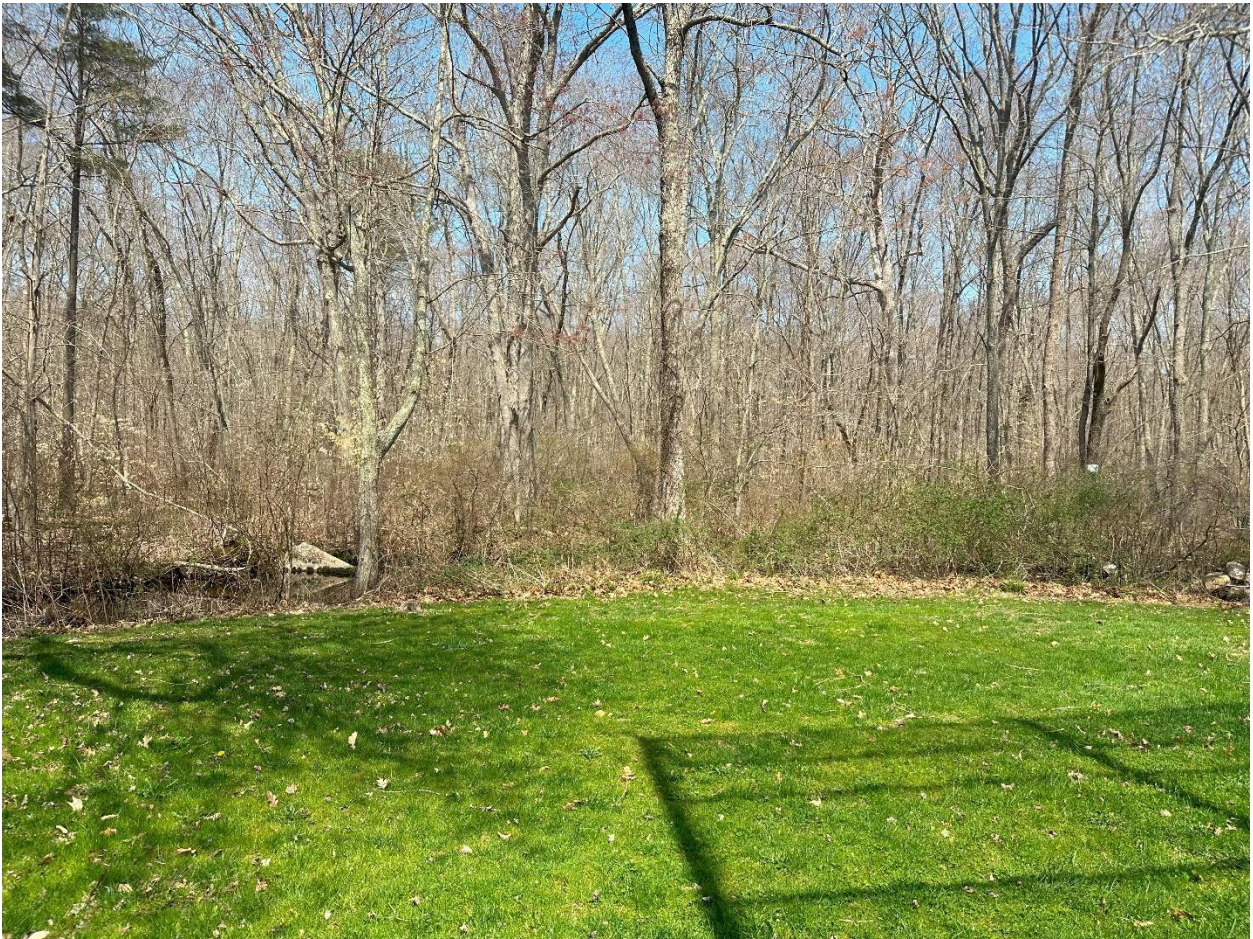
This image shows the large presence of invasives along the entirety of the bank of the brook. It also highlights the lack of diversity with grass being the dominant plant here.

We selected this site over the other one since it scored only a 1 on the TN Site Assessment. This site was also more easily accessible for actually getting plants, volunteers, and possible trucks/equipment to the site. The TN Site Assessments will be included at the end of this report.

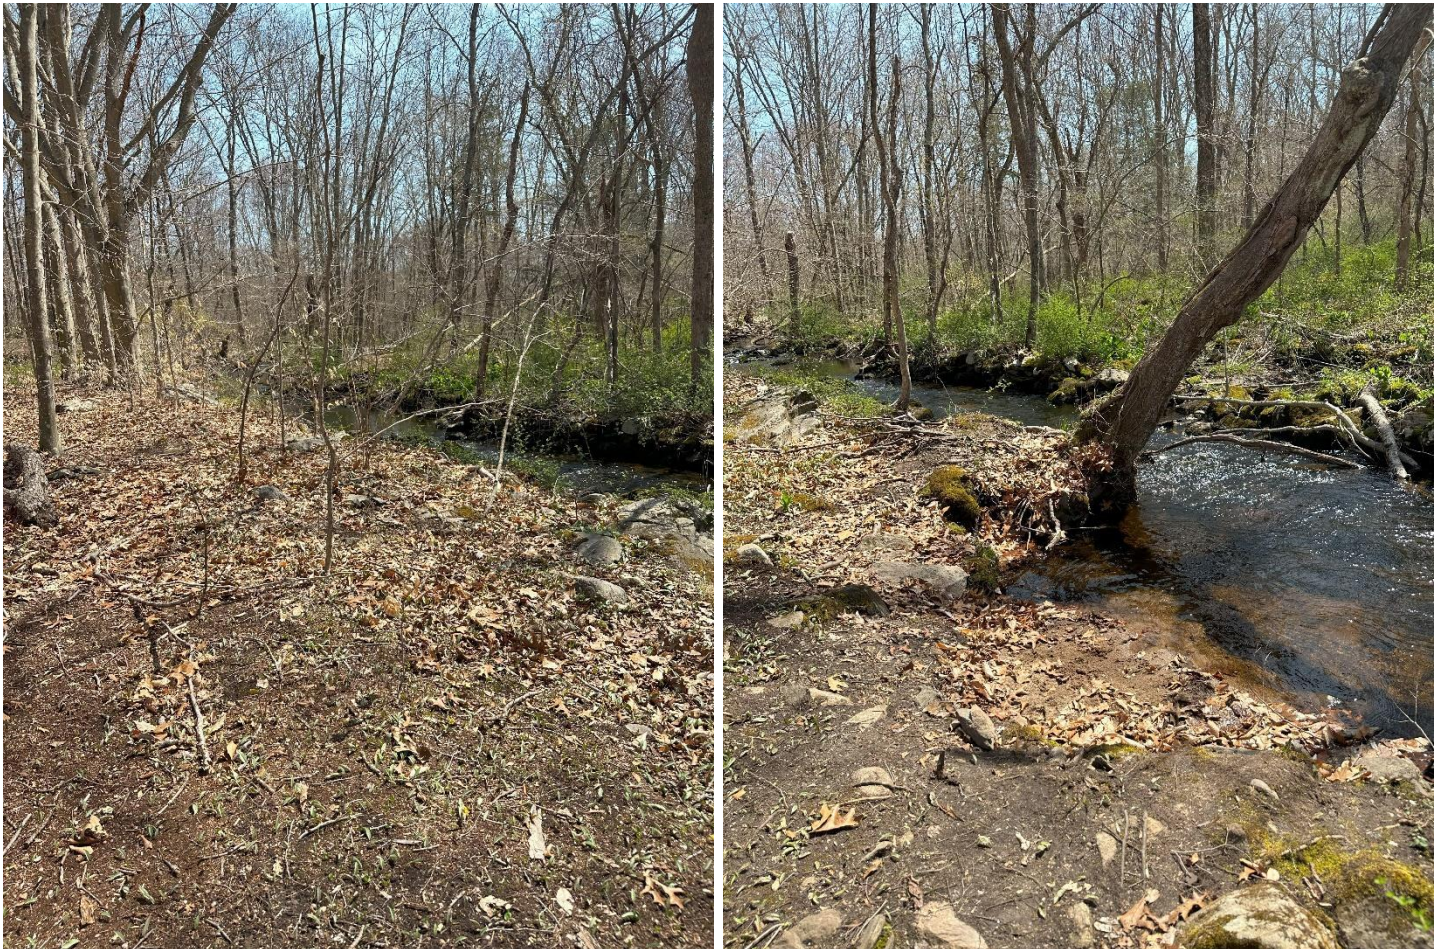
evidence of erosion of the banks near this site with one tree having many exposed roots and looking like it may fall into the water (image included below). There were some invasive species present, but not to the same extent as seen in the Pfizer Field site. There were also more native species already present, and the site seemed to be in better shape. There still wasn't an actual buffer but it did not need as many plants added and wouldn't require extensive work to be done prior to any additions being made.

The image on the left shows the majority of the site, you can see more variety in the plants that are present and less extensive invasive species cover. The image on the right shows the erosion near the tree at the center of the picture. The roots are mostly exposed and you can clearly see the lack of stability of the bank. Both images also show the large number of rocks that are scattered both near the bank and throughout the site.

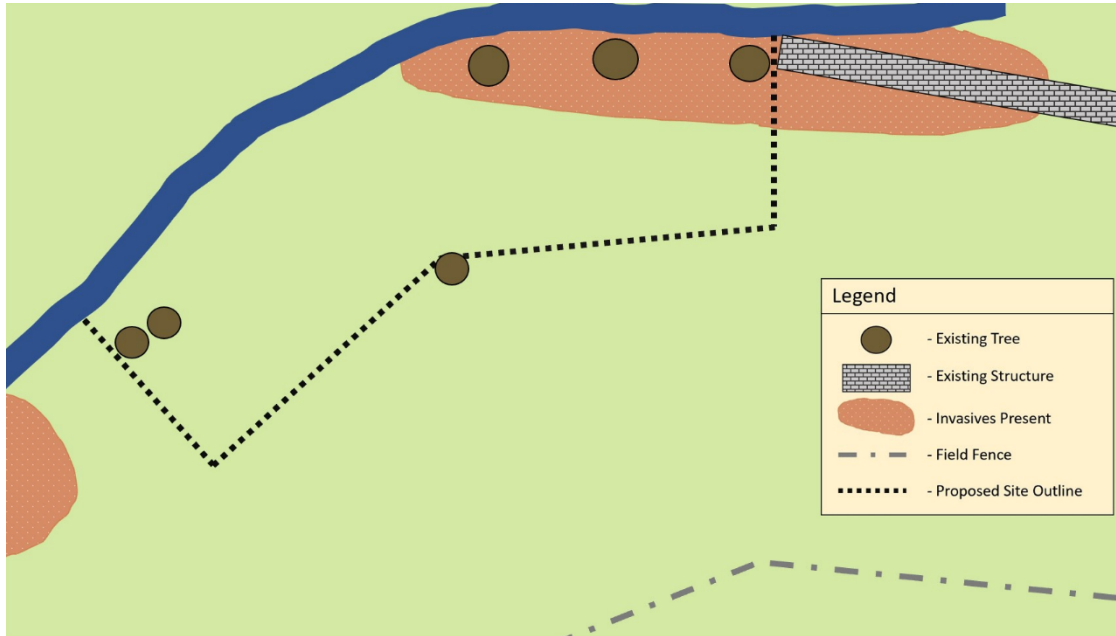
Jack focused on the actual plant selection, but I wanted to include the graphics that I created here. The first graphic shows the site before our suggested changes while the second shows the changes that we wanted to make.

Before any planting can be done the invasive species would need to be removed and the garbage found around the site would need to be cleaned up. Once that was done the land would need to be tilled in order to prepare it for planting. The layout of the plants can be seen in the graphics above. We also wanted to keep an area where the water could still be accessed since the site is near a baseball field and sometimes balls are knocked into the water. The access allows them to still be able to retrieve any lost balls. It also allows for any recreational use of the brook to still be done, as the path that led to the water looked well worn down and frequently used.

The plants that we selected consisted of many pollinator friendly plant species along with some grasses that would be planted right along the bank to help with stability. We also included one fern species in order to have some green foliage that would be long lasting to help the aesthetic value of the site. The flowering plants would also help this aesthetic value which was important to us for this site since it was in such a public space. We wanted people to be interested in this new addition and possibly help get more riparian buffers added elsewhere after seeing what it could do here.
